**THE CALIFORNIA EARTHQUAKE OF APRIL 18, 1906**

**REPORT**

**OF THE**

ANDREW C. LAWSON

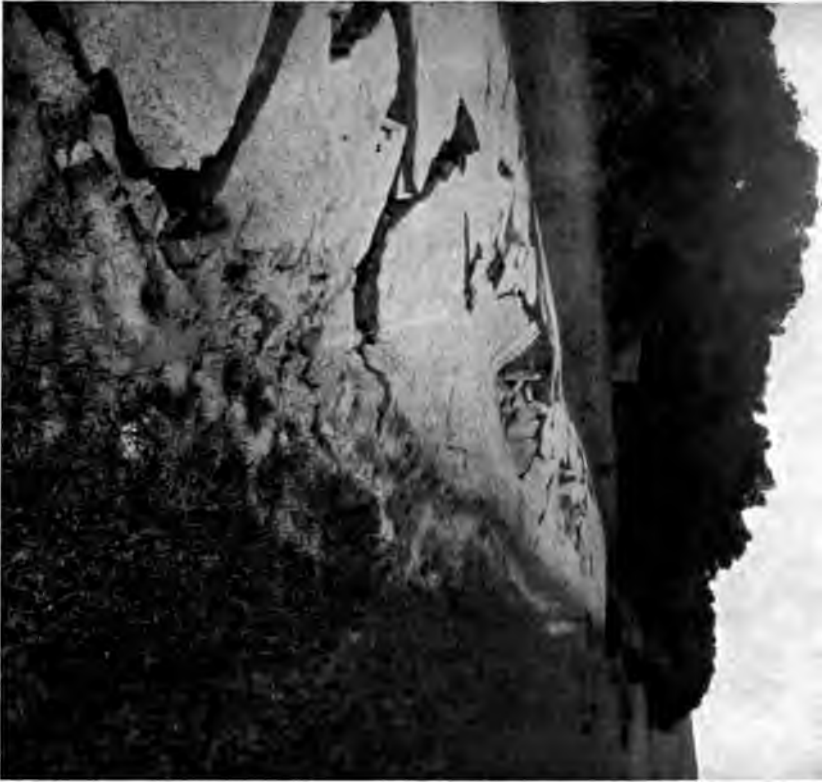
A. Road embankment broken by shaking of soft ground beneath. Southwest of Point Reyes Station and 10 rods from fault-trace. G. K. G.

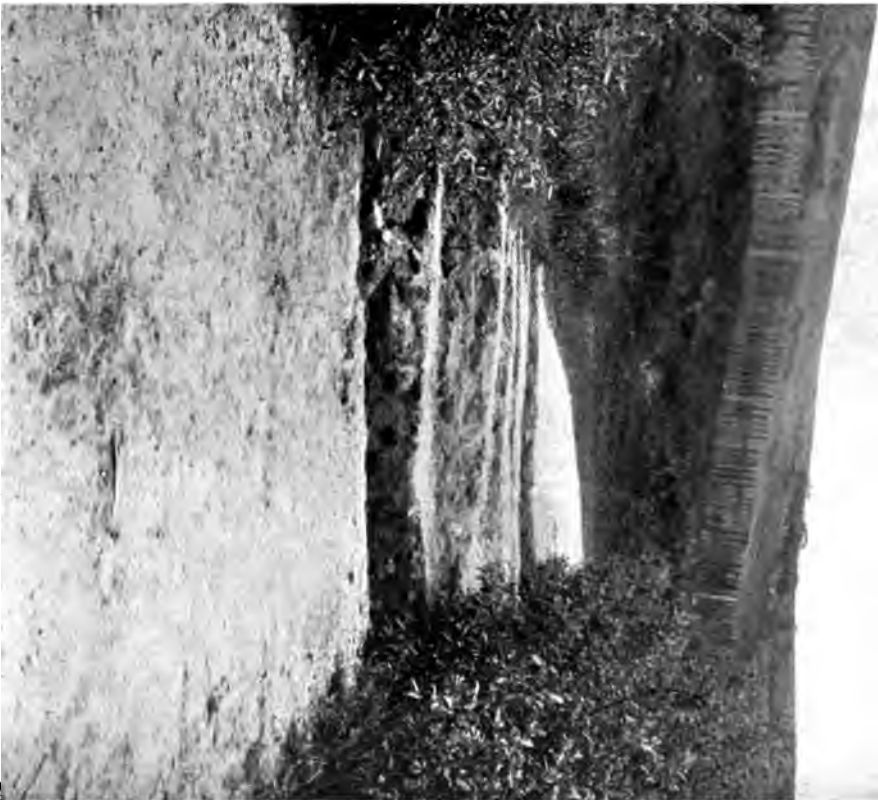
B. Faults in road embankment, southwest of Point Reyes Station. Fault-trace is beyond fence. Ground lurched toward marsh of Bear Valley Creek. G. K. G.

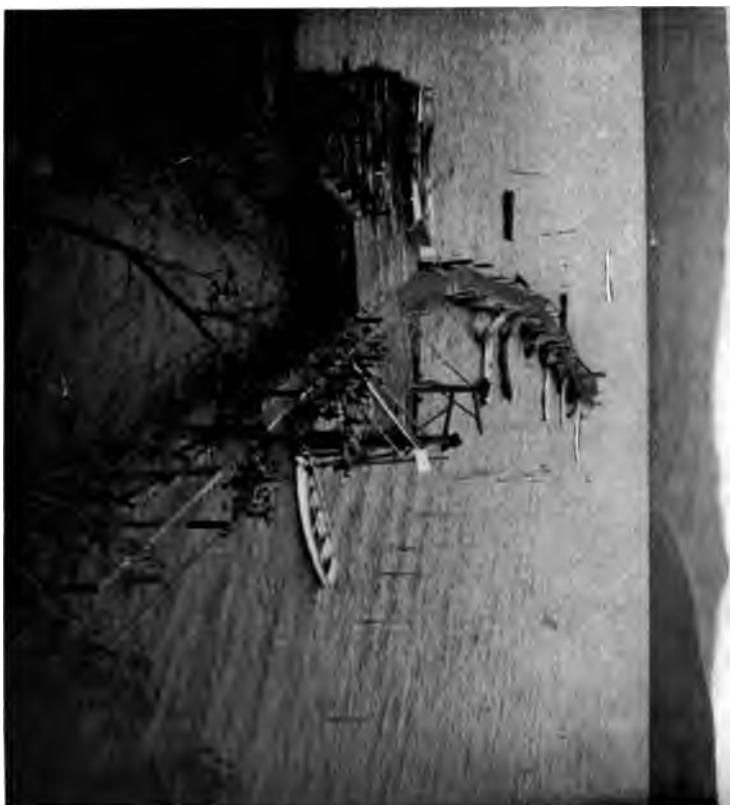
B. Bailey's pier at Inverness. Originally straight; shifted and much broken by earthquake. In subsequent repairs curvature caused by earthquake was retained. G. K. G.

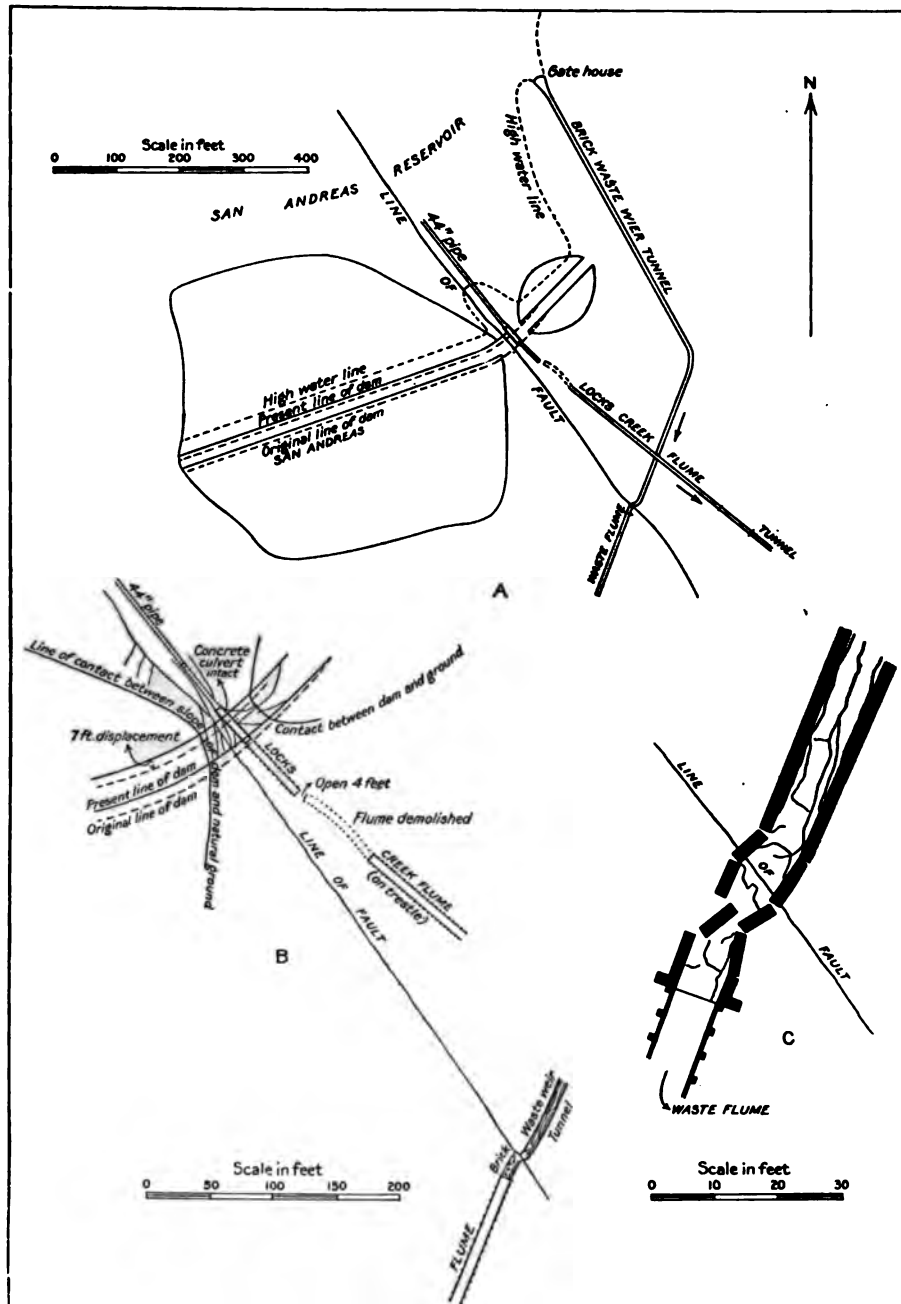
FIG. 36.— Intersection of San Andreas dam by fault. A. Plan of dam in two parts, with rock between. B. Relation of dam to waste weir tunnel. C. Detail of waste weir tunnel.

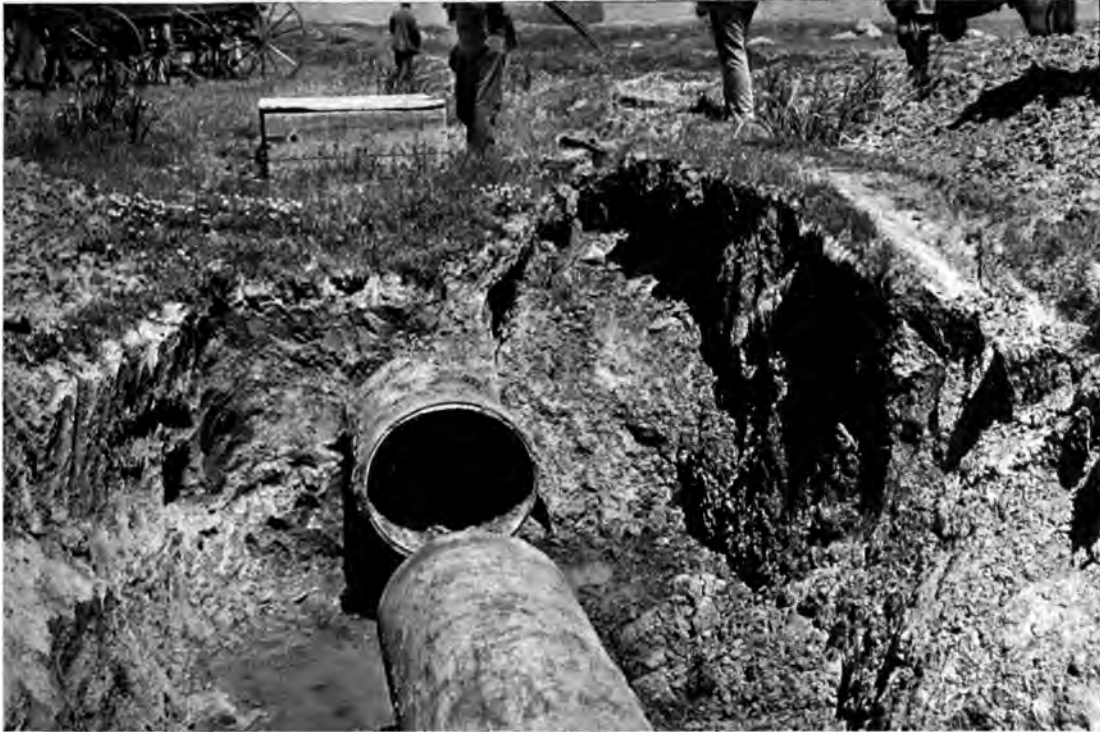
A. Rupture of 30-inch water-pipe by fault. Northwest of San Andreas Lake. A. C. L.

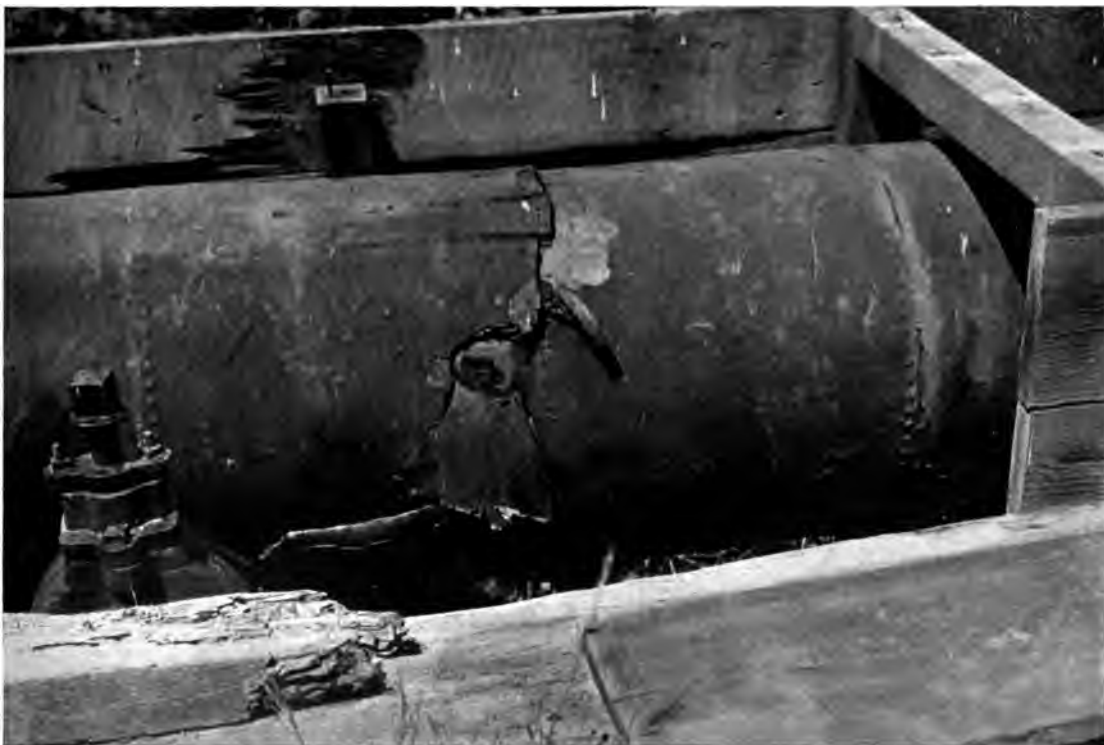
B. Thrust of 30-inch water-pipe by fault, northwest of San Andreas Lake. Amount of telescoping is 58 inches. A. C. L.

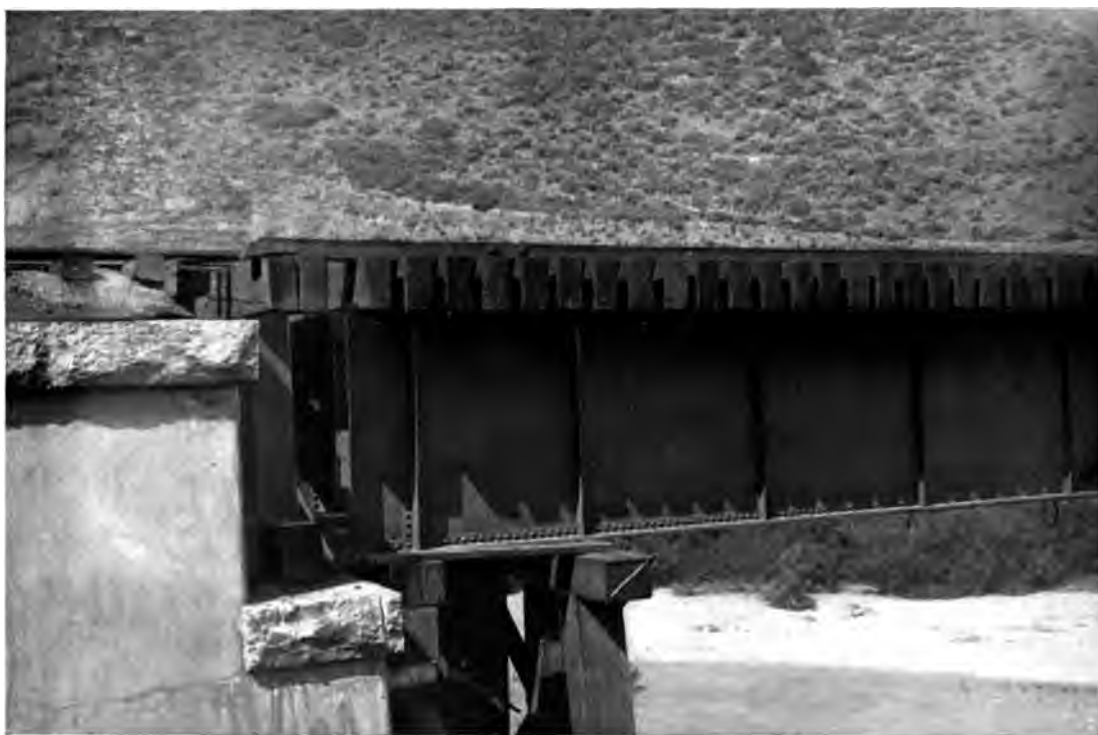
B. Steel bridge over Pajaro River, near Chittenden, dragged from its abutment 3.5 feet. Compare Fig. 43. A. C. L.

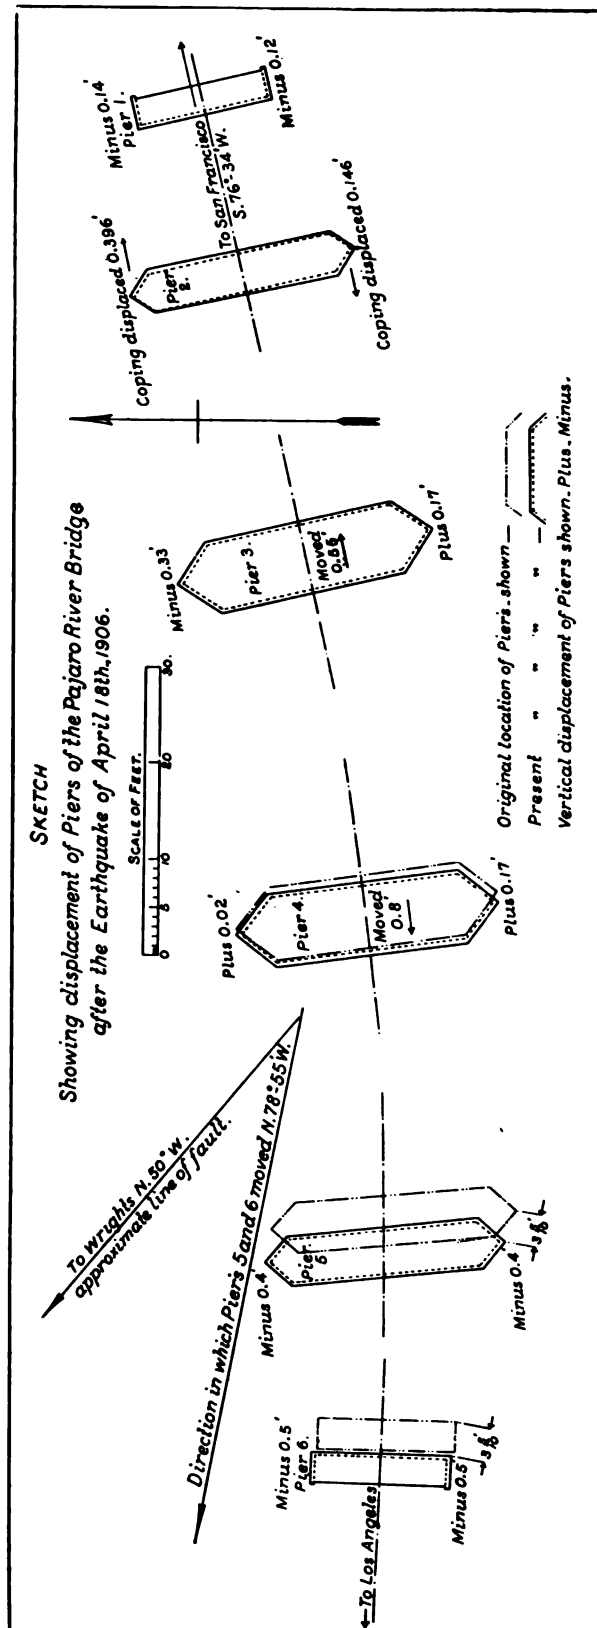
FIG. 43. — Displacement of piers of steel bridge at Chittenden.

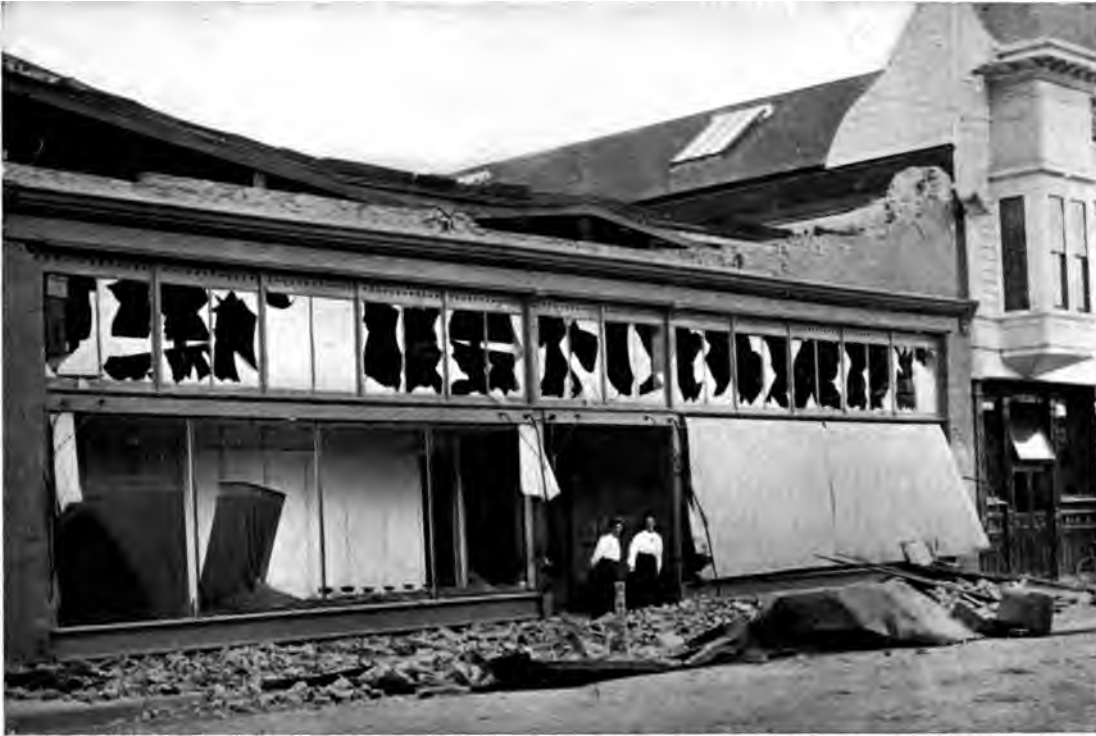
A. Wrecked stores. Ferndale, Humboldt County.

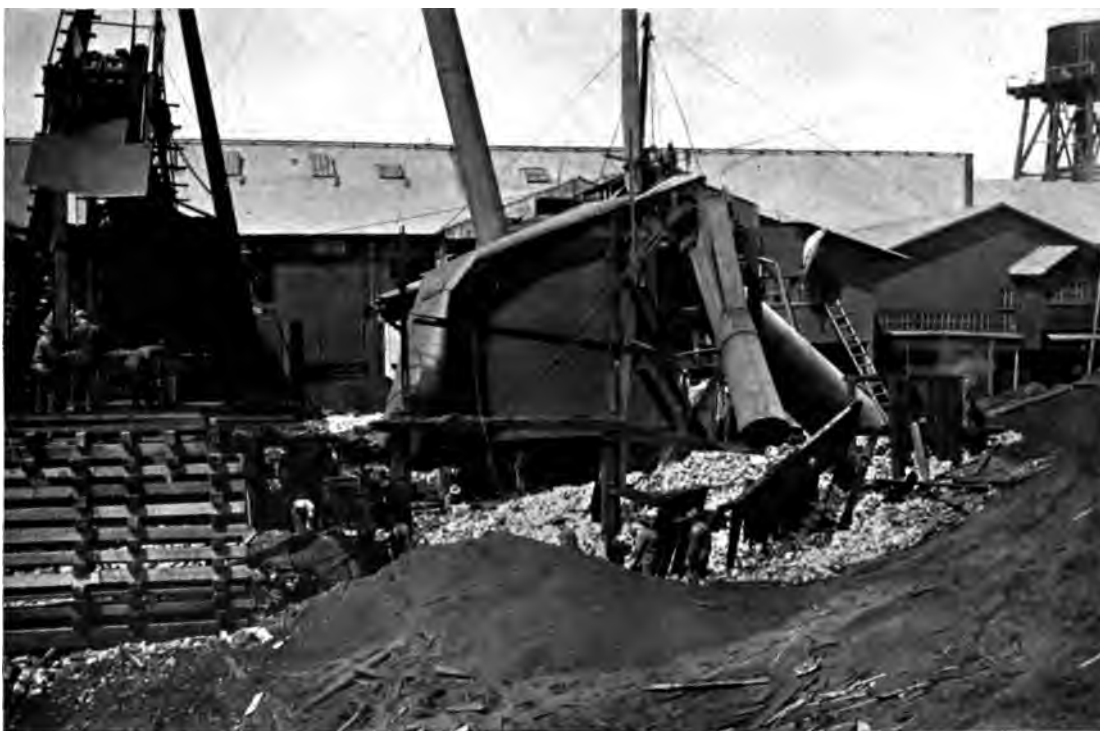
B. U.S. Co.'s mill, Fort Bragg. Smoke stack 5 feet in diameter. Entire structure thrown out of plumb to south, 1 foot in 20 feet.  
L.

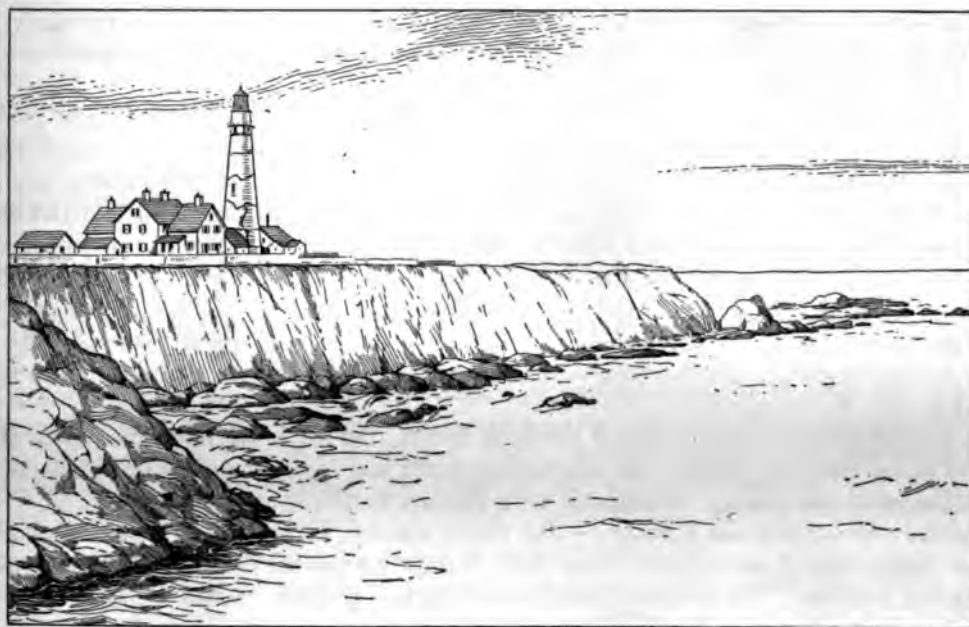
FIG. 49. — Cracks in light-house tower, Point Arena.

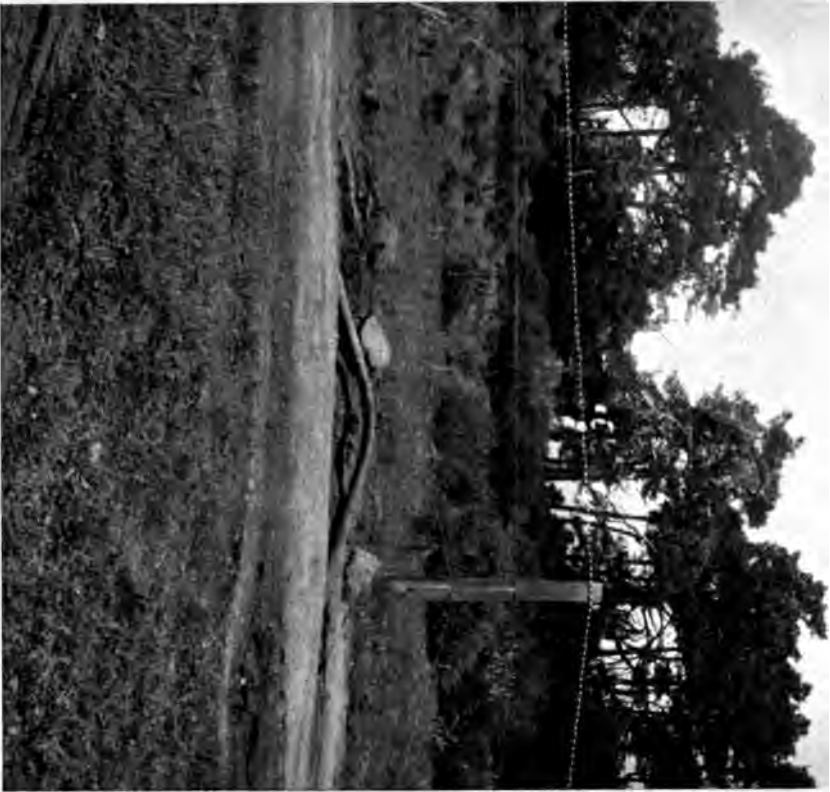
A. Buckled water-pipe, Inverness. G. K. G.

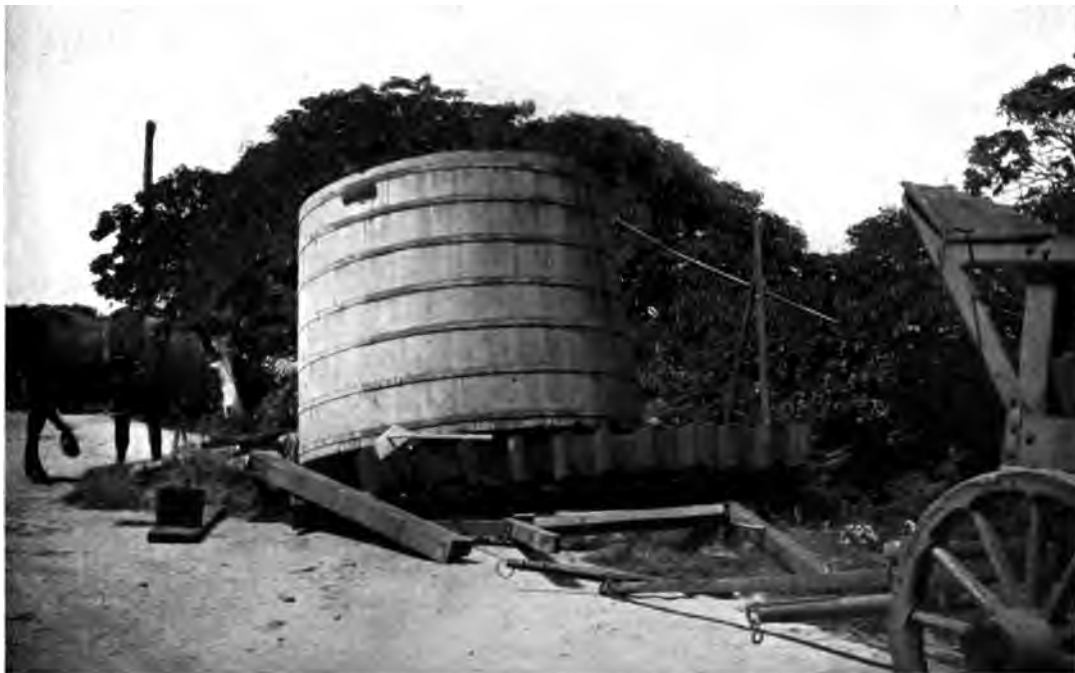
B. Wrecked water-tank near Inverness. G. K. G.

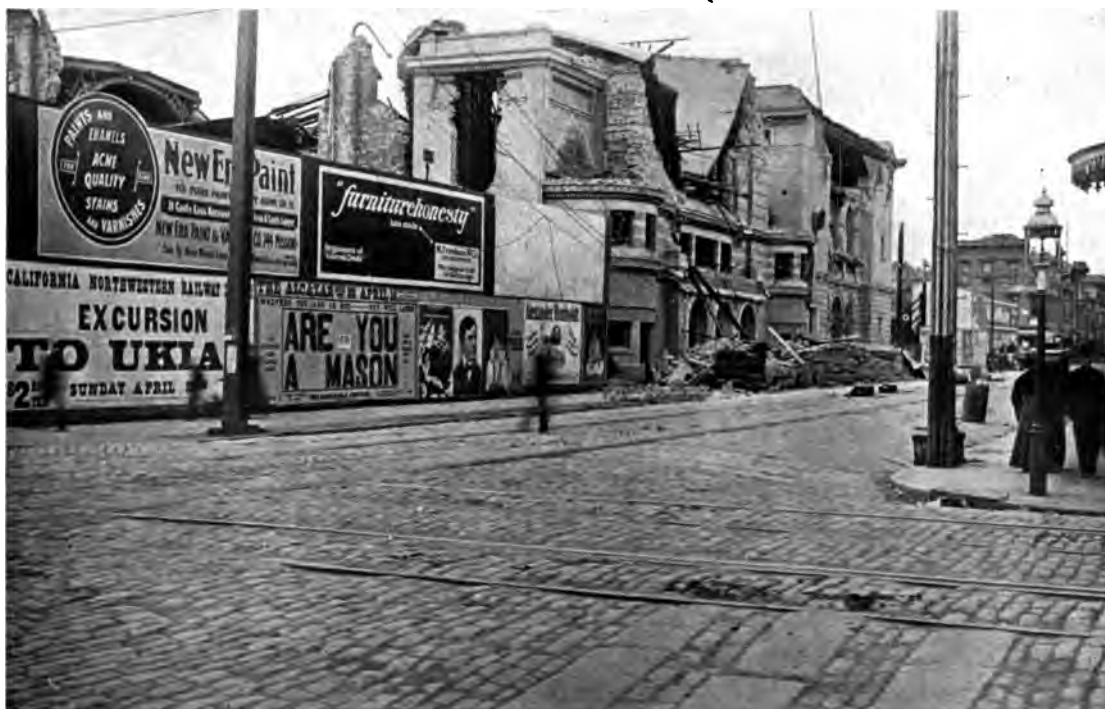
B. Geary Street, between Filmore and Steiner Streets, San Francisco. Buildings of mediocre construction on sand and alluvium of no great depth. A. C. L.

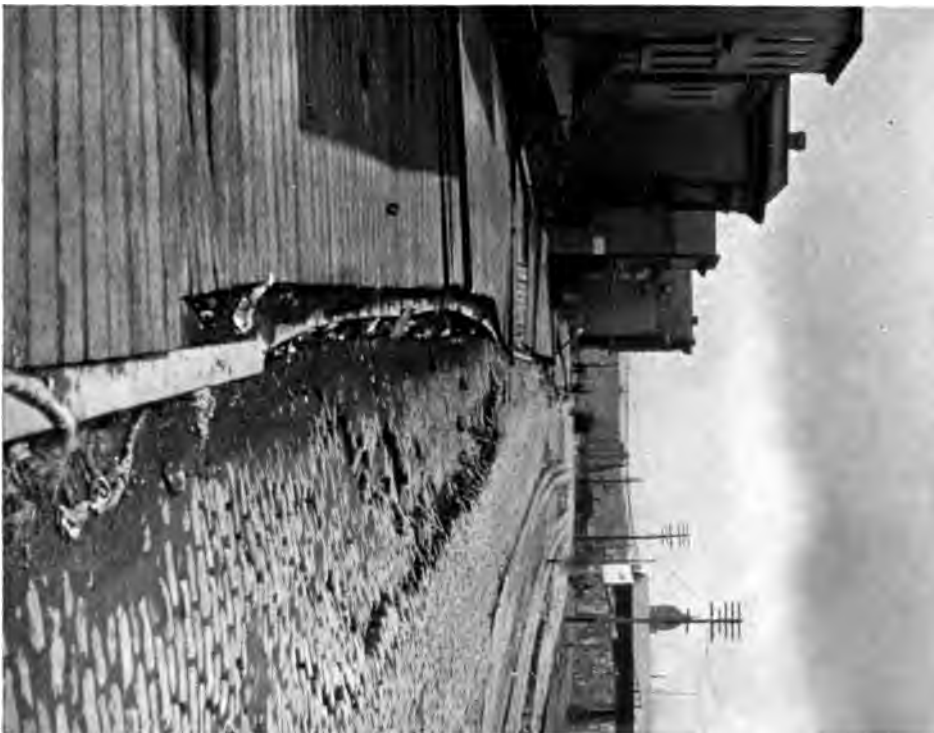
**B. Ninth Street, between Bryant and Brennan. Westward lurching of land toward former creek channel where Dore Street now is. G. K. G.**

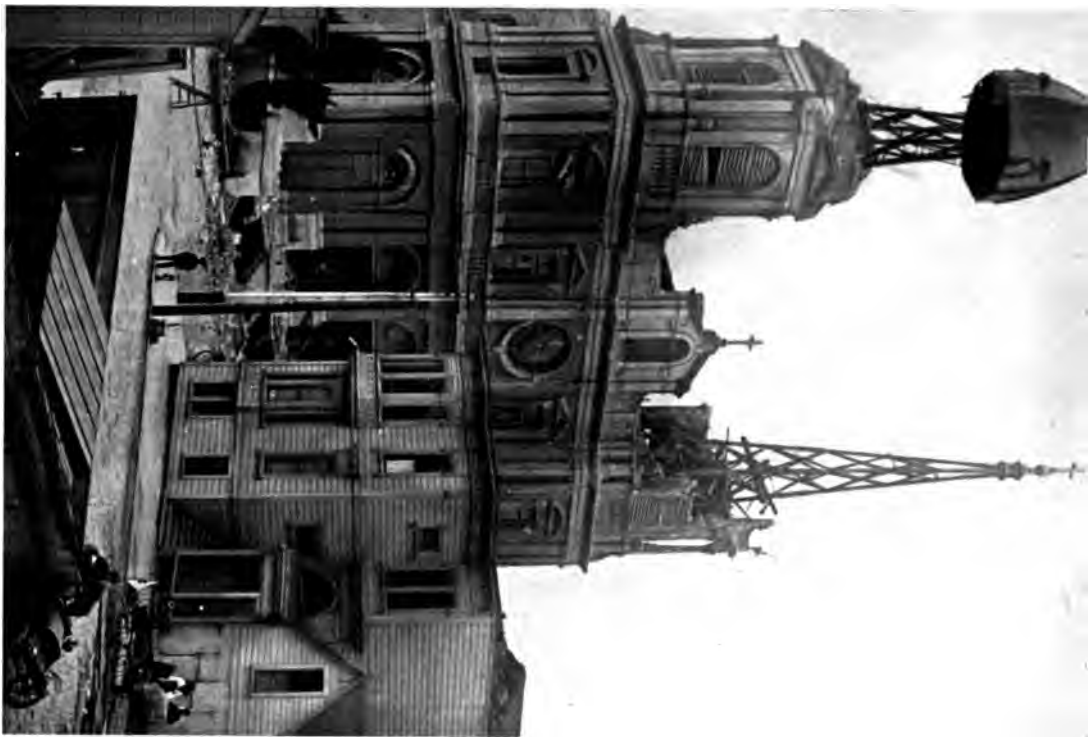
A. St. Dominic's Church, Bush and Steiner Streets. Brick and masonry structure upon sand and alluvium of no great depth. A. O. L.

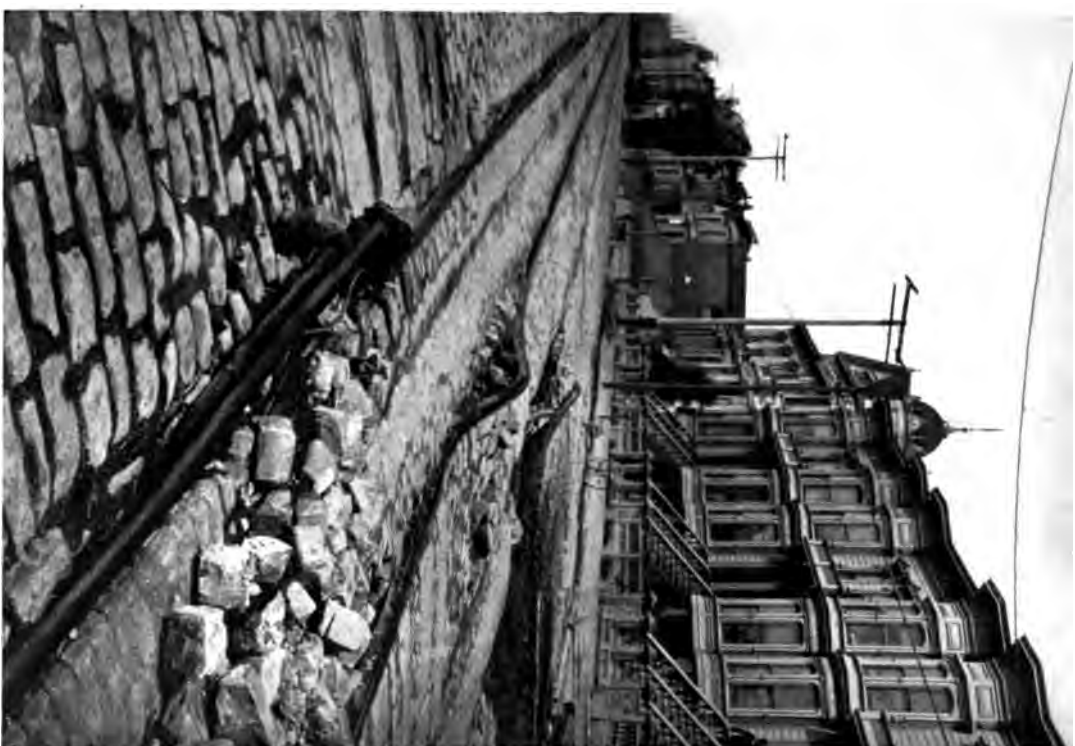
B. Looking south on Howard Street from near Seventeenth Street. Compression of car rails. G. K. G.

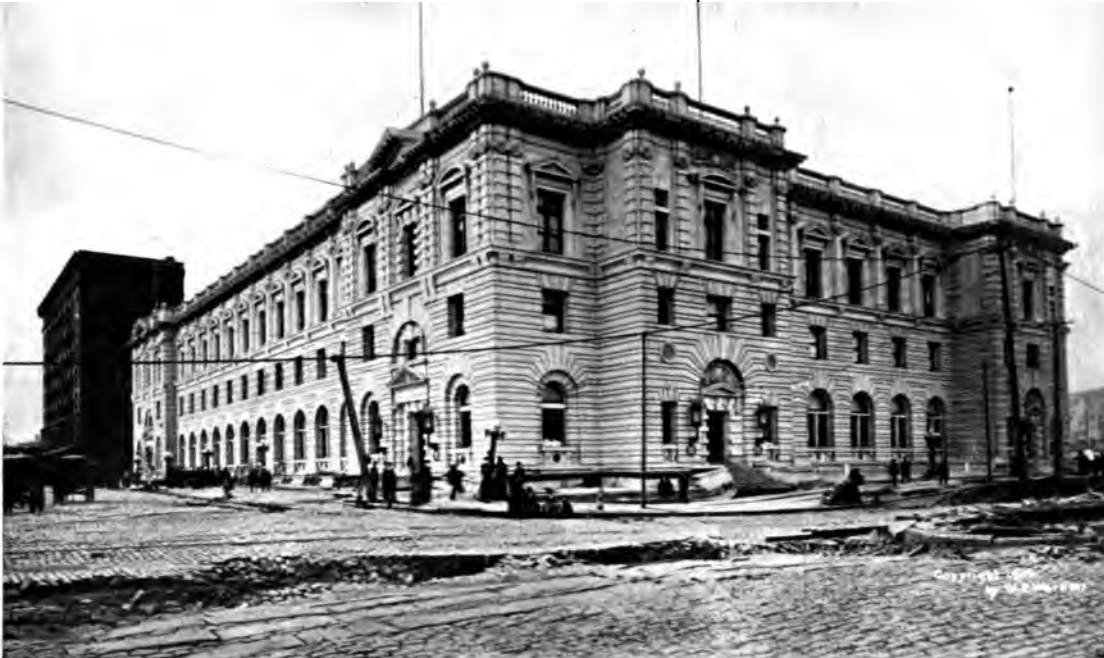
B. San Francisco Post-office, Mission and Seventh Streets. Near corner of building is on edge of old marsh. Ground over marsh sank and lurched. W. E. Worden, Photo.

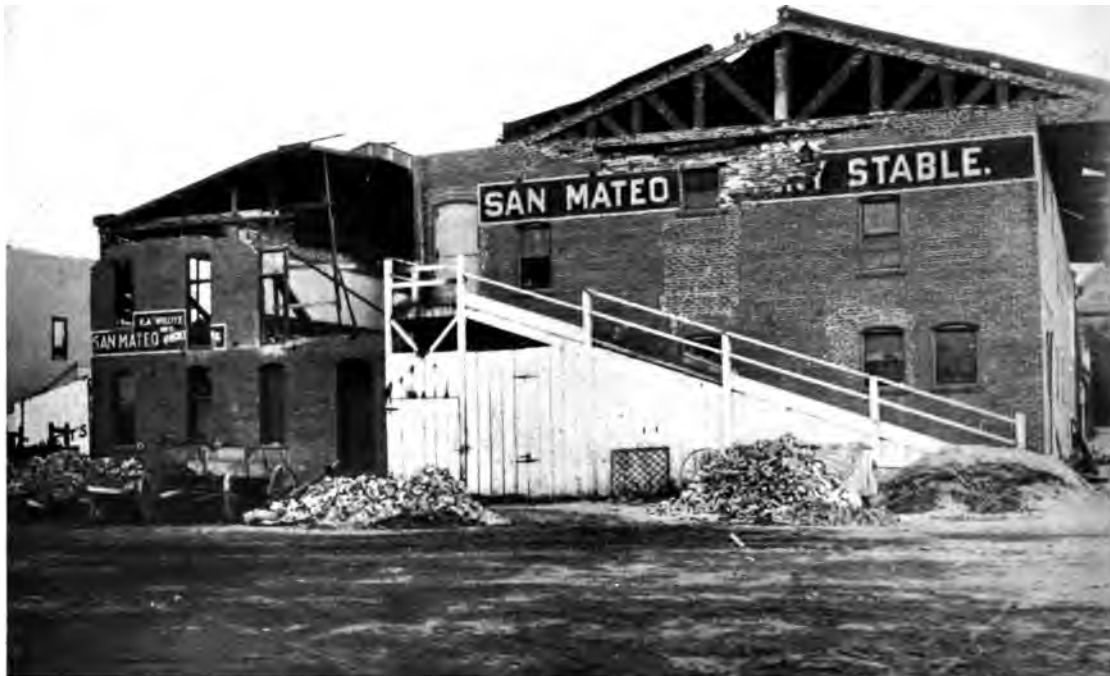
B. Brick stable, San Mateo. Upper story was thrown out and roof dropt one story. Per J. O. B.
